# Superior Home Inspections

## Home Inspection Report

**123 Sample Report Ln  
Central , LA**

Inspected on Sat, May 4 2019 at 9:09 AM

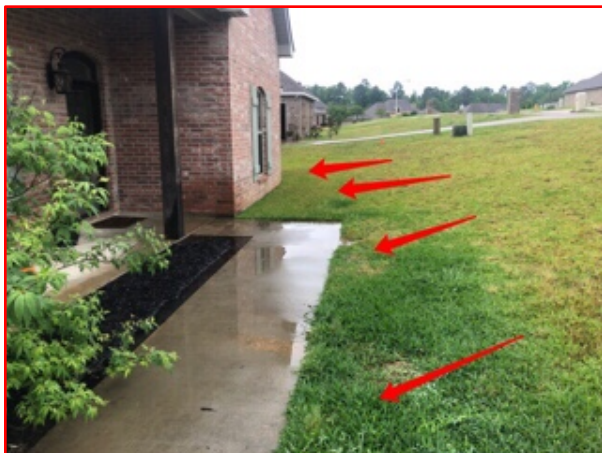
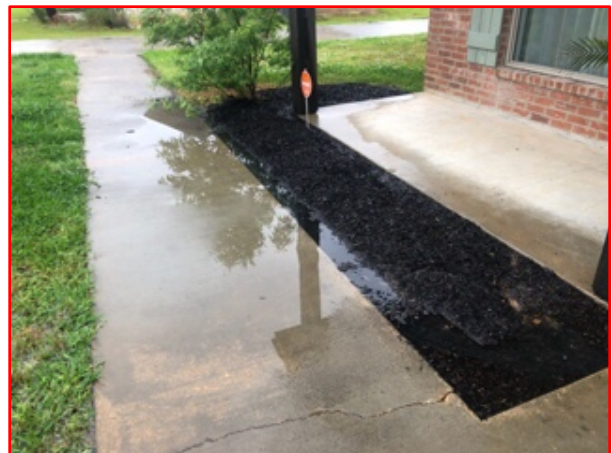
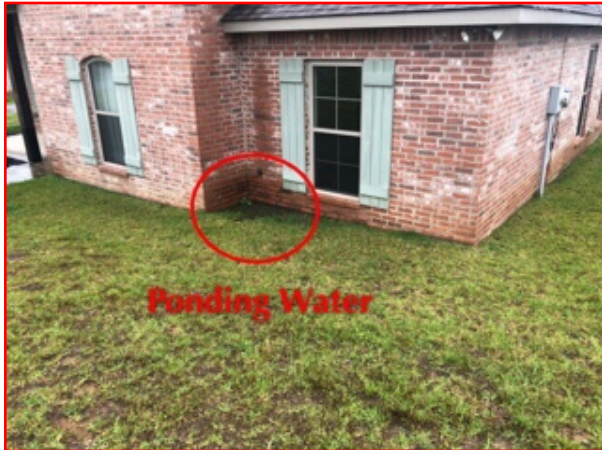
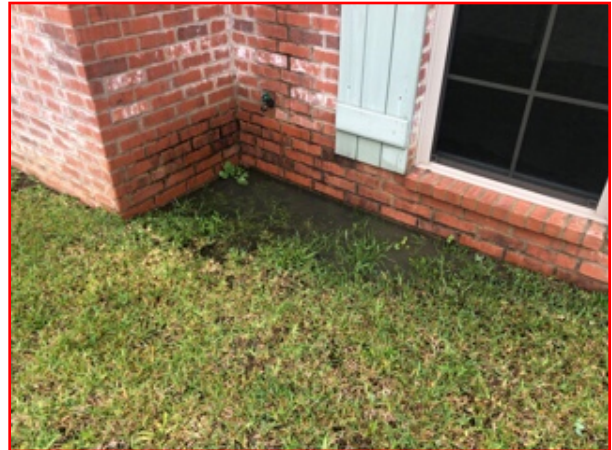
1) Grading at front of structure slopes towards the house and foundation, with water being held at front porch area and corner to the right of front door. This will eventually have negative effects on the foundation strength. Recommend licensed landscape contractor evaluate and repair to eliminate water being held around foundation perimeter, using additional drainage, the use of a swale, or grading.

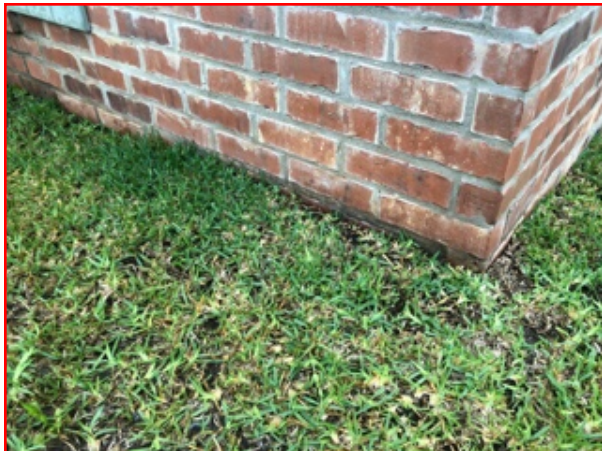
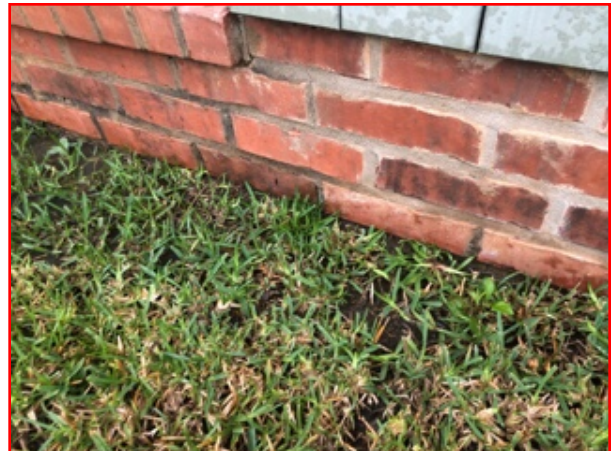
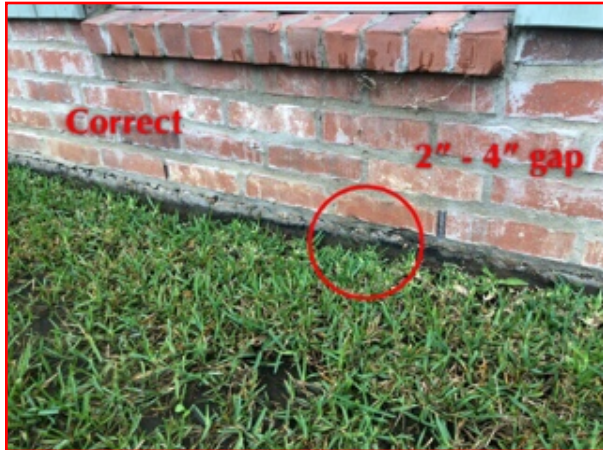
2) Recommend a 2" - 4" gap between the house siding and the foundation. When the soil is above the siding, moisture and insect intrusion is possible. Recommend lowering soil around perimeter to allow for the 2" - 4" gap. (Front right of house)

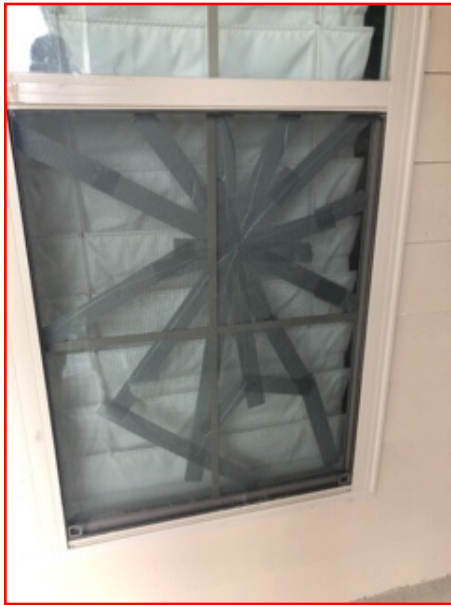
Figure 4-1

3) Window noted in picture is cracked, recommend replacing. (Window in living area)

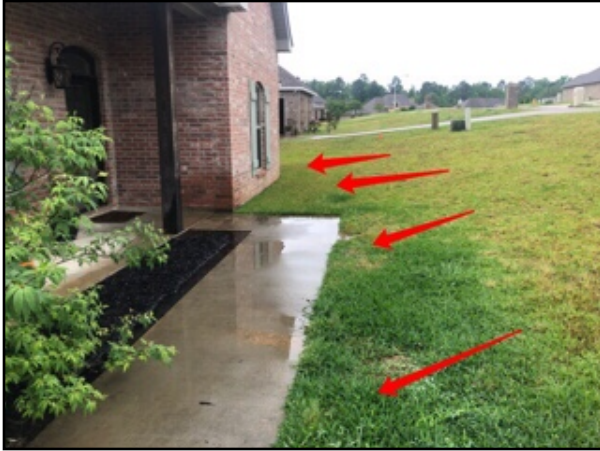
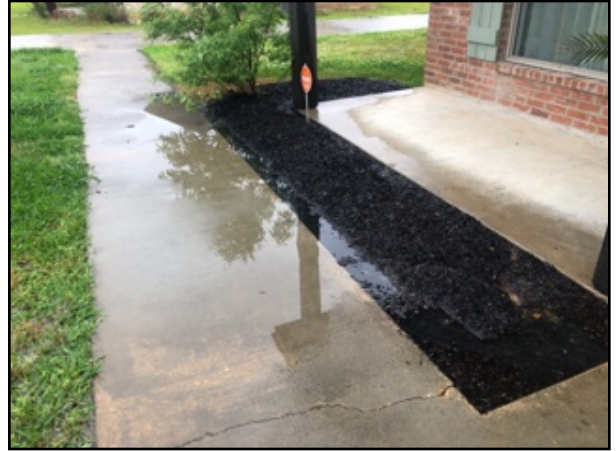
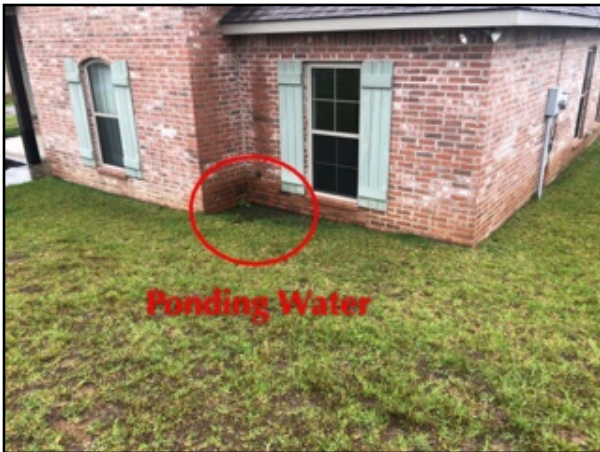
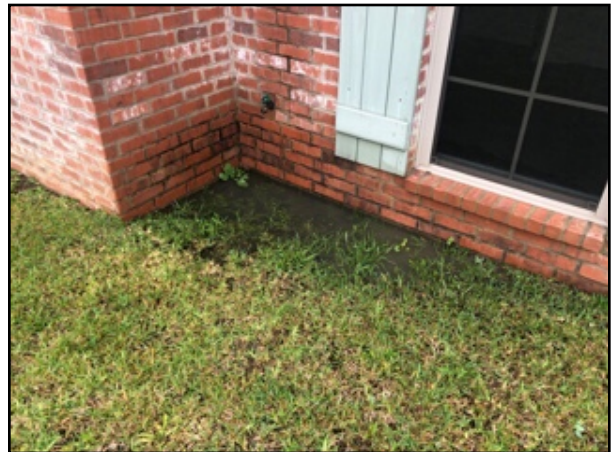
Grading at front of structure slopes towards the house and foundation, with water being held at front porch area and corner to the right of front door. This will eventually have negative effects on the foundation strength. Recommend licensed landscape contractor evaluate and repair to eliminate water being held around foundation perimeter, using additional drainage, the use of a swale, or grading.

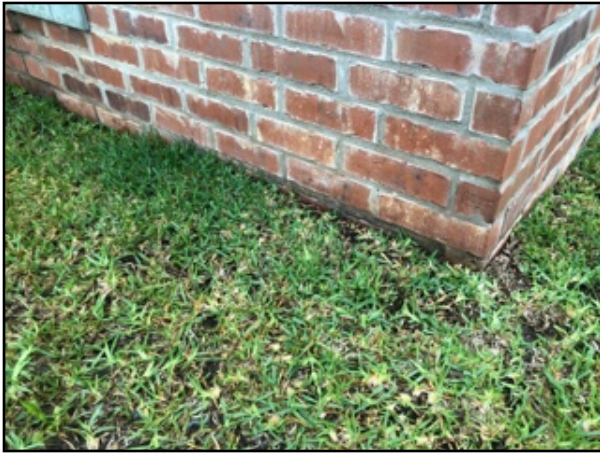
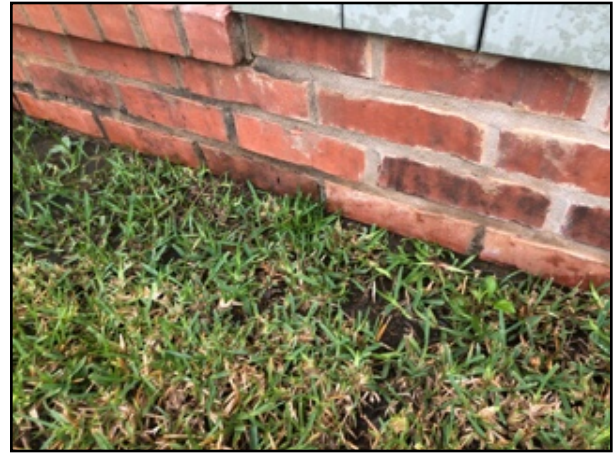
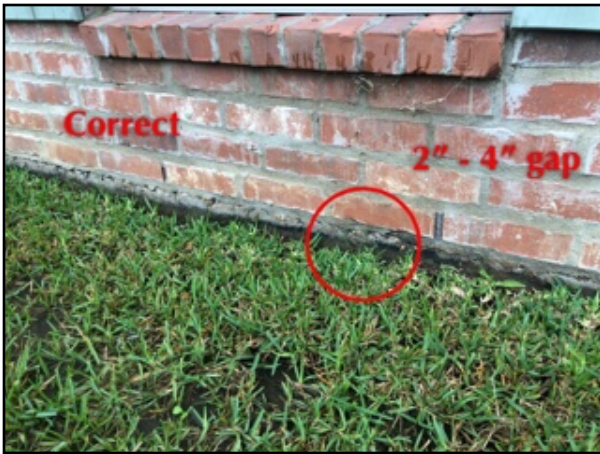
Recommend a 2" - 4" gap between the house siding and the foundation. When the soil is above the siding, moisture and insect intrusion is possible.

Recommend lowering soil around perimeter to allow for the 2" - 4" gap. (Front right of house)

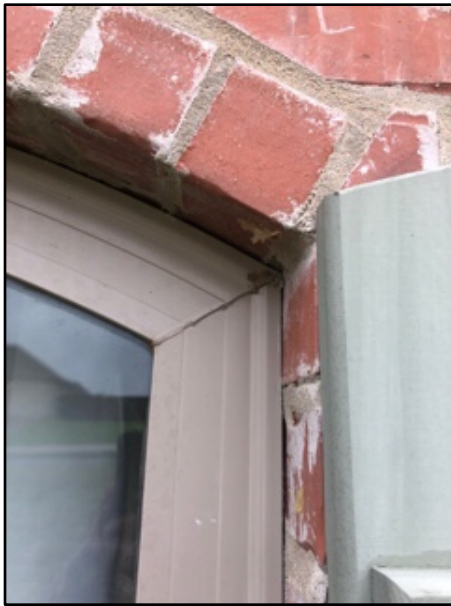
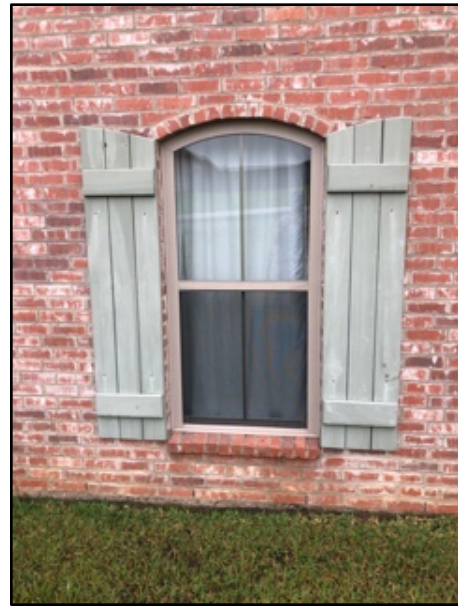
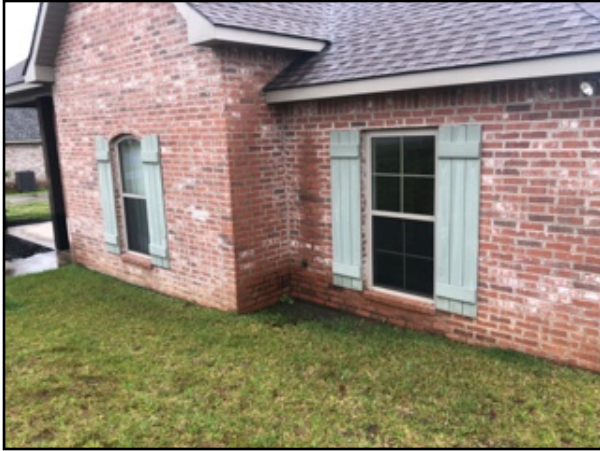
To increase energy efficiency, and prevent water intrusion, recommend caulking around all exterior windows.

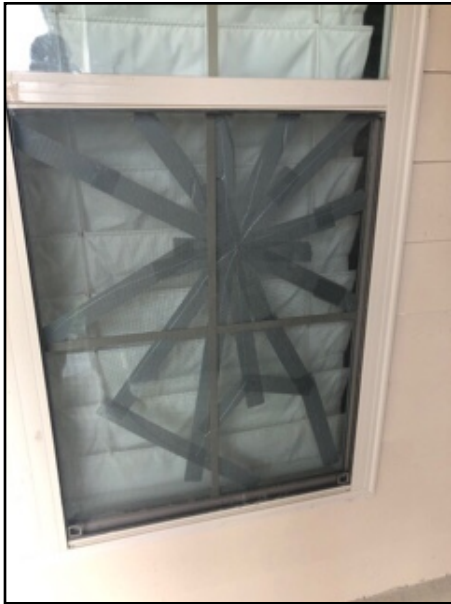
Figure 4-1

Window noted in picture is cracked, recommend replacing. (Window in living area)

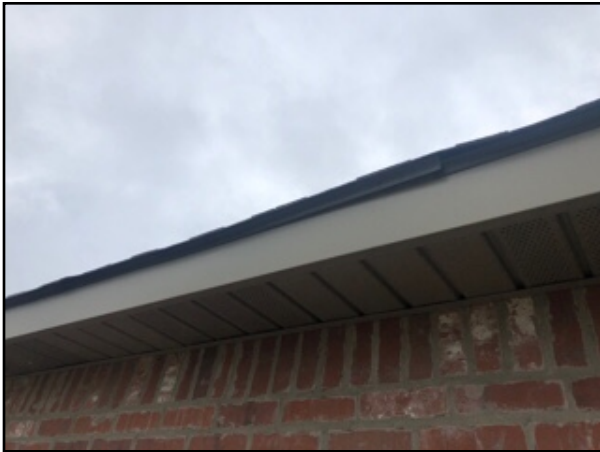
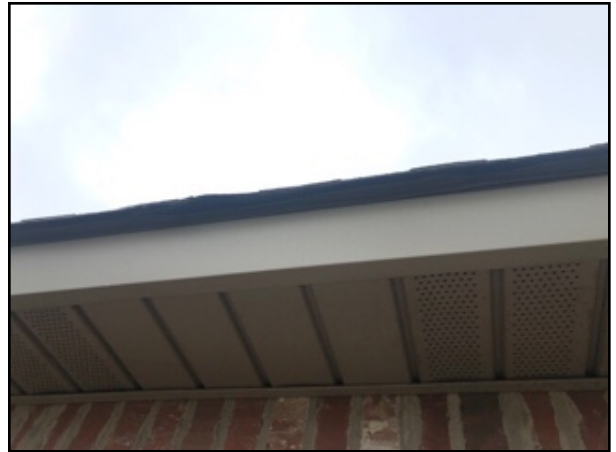
Drip edge above garage is bent. Recommend straightening back to its original shape so that it performs correctly.

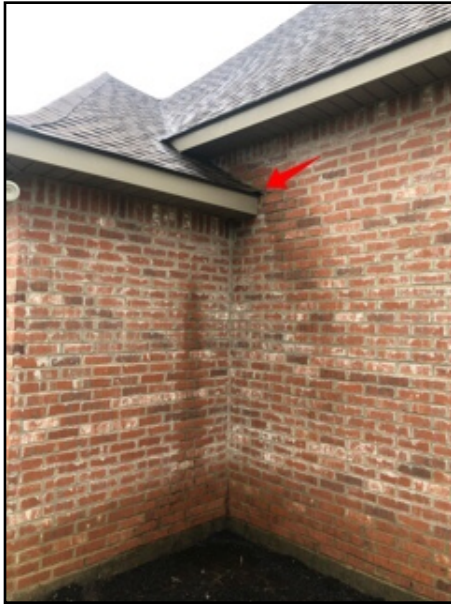
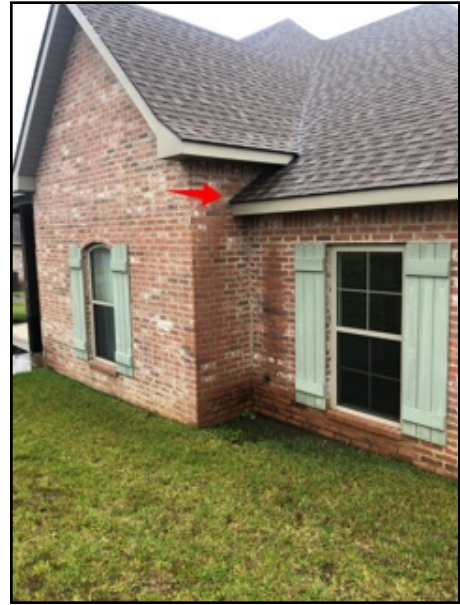
Recommend kick out flashing in areas where water will drain down house siding, eventually causing it to deteriorate faster.

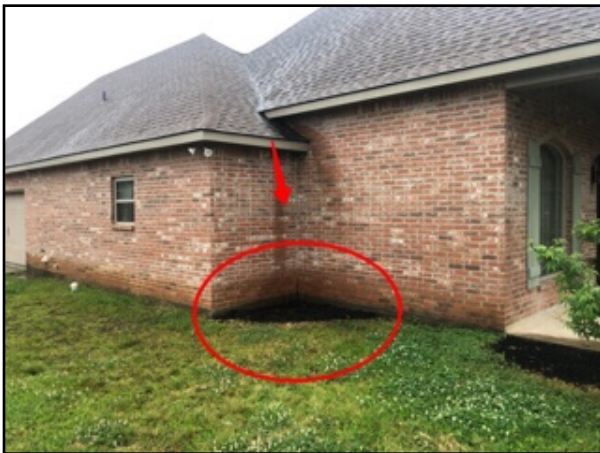
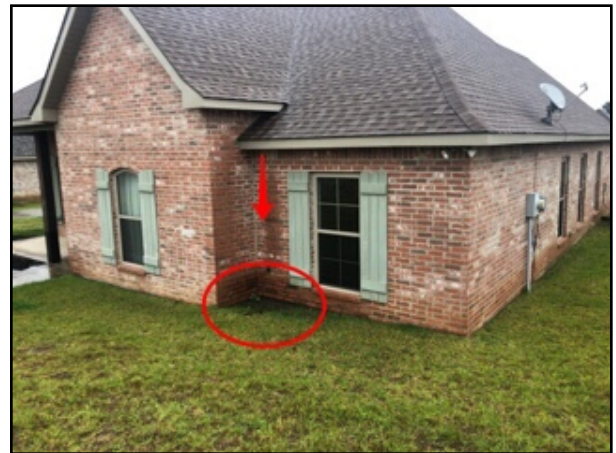
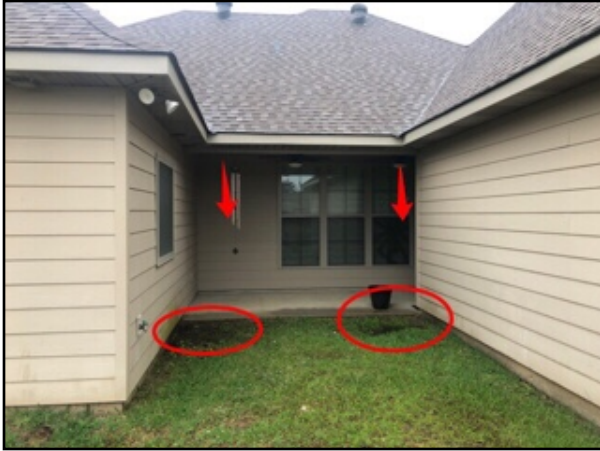
Area noted has significant amount of water runoff from roof. Gutters in this location would help move water away from foundation quicker.

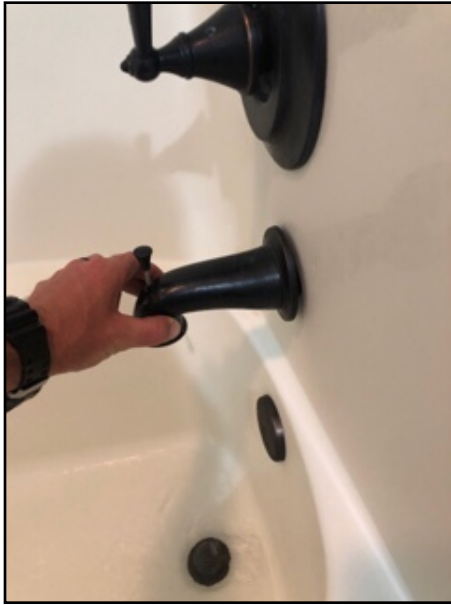
Figure 12-1

Bath tub faucet and spout are loose on wall, recommend securing properly to prevent water from entering behind hardware.

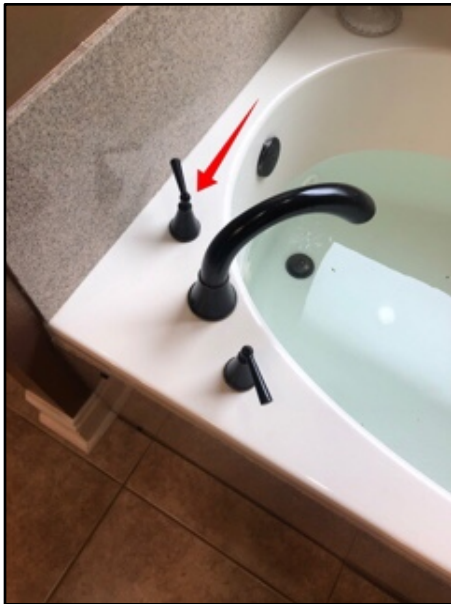
Figure 13-1

Bath tub faucet noted in picture has no stop present. The faucet will spin 360 degrees. Recommend repairing.

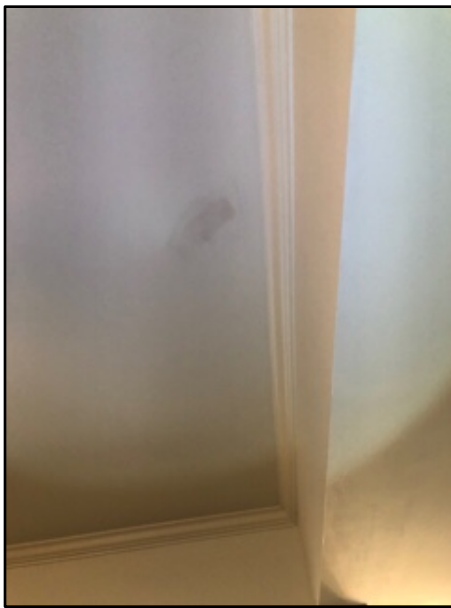
Figure 15-1

Comment 15:  
Stain noted on ceiling.
